REFERENCE	BT_2010_FR20_03_UK
DATE	21th February 2010
SUBJECT	Parts available from Valencia collective tests
PART	Exhaust thermal shield, rear extinguisher support, crankshaft sensor additional loom

**FORMULA
RENAULT 2.0**

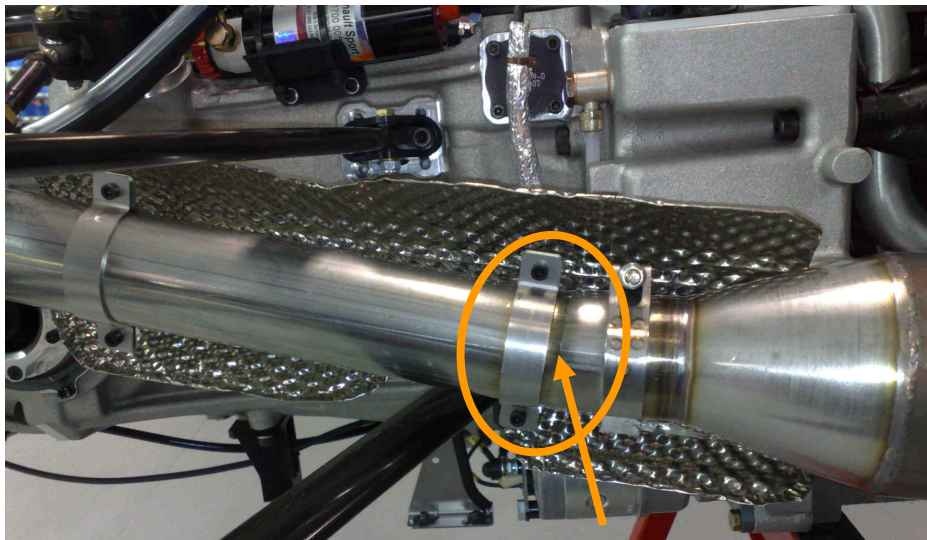
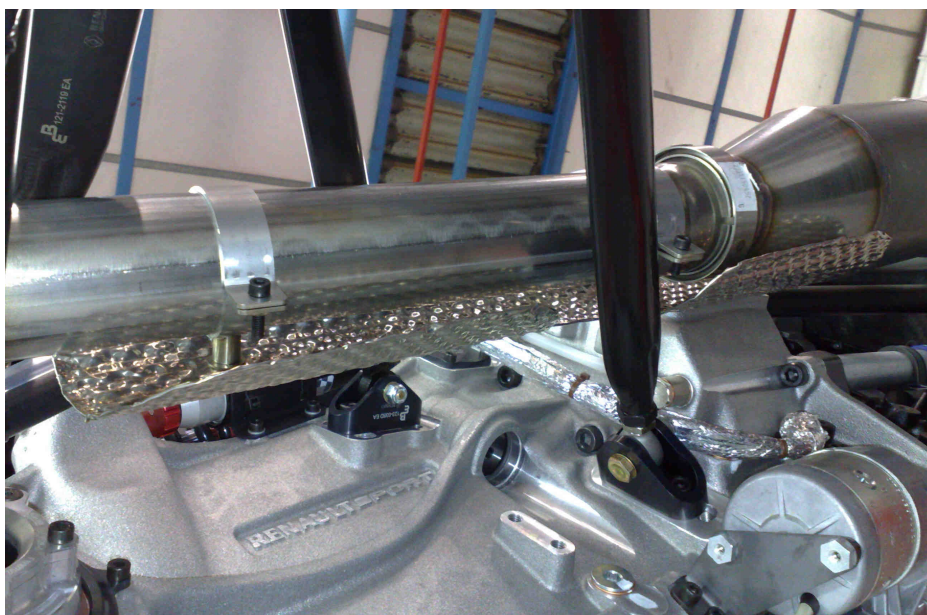
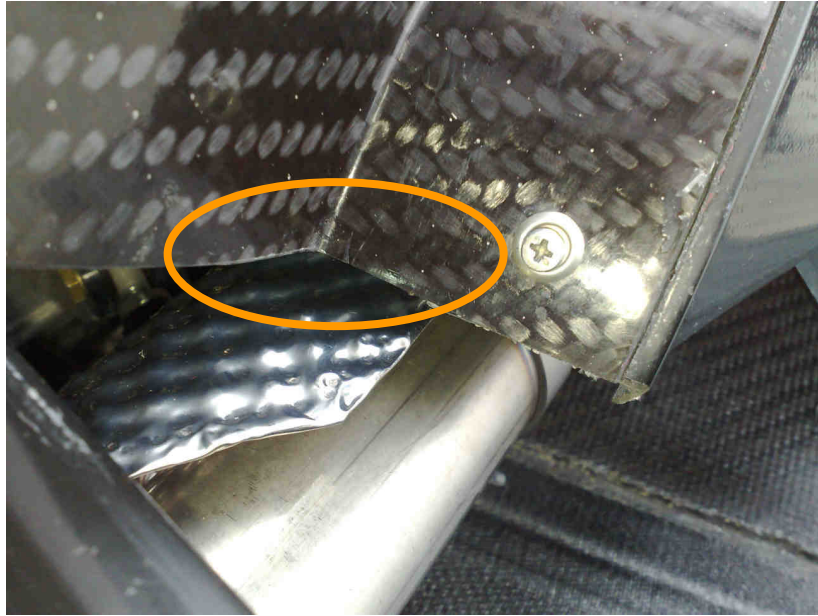
The front support must be in contact with the shoulder of the intermediate line

On some cars, it could be needed to slightly bend the thermal shield to avoid any contact with the engine cover.

An exhaust thermal shield is now available from the Renault Sport spare parts Department. This thermal shield is mandatory and will be added to the Formula Renault 2.0 nomenclature as soon as possible.

The thermal shield is delivered with its supports.

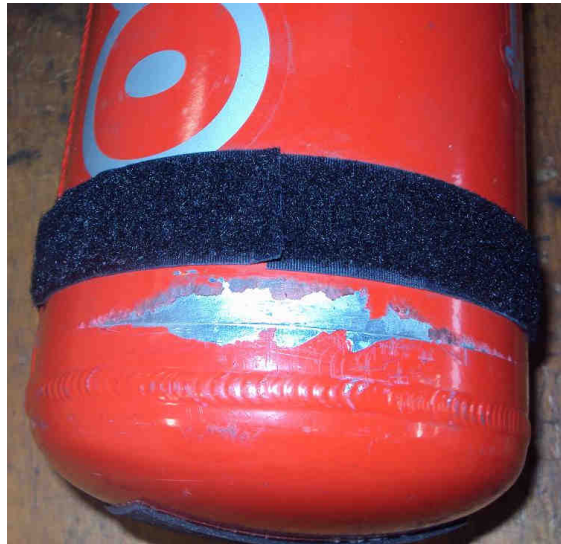
Following several issues with the extinguisher, please check if your extinguisher is not worn out as shown on the picture below:

Due to vibration, the extinguisher wears on its rear support

To avoid this wear, a new rear support is now available from the Renault Sport spare parts Department. If your extinguisher is too much worn, a Renault Sport scrutineer must check it. If needed, the extinguisher will be exchanged with a new one.

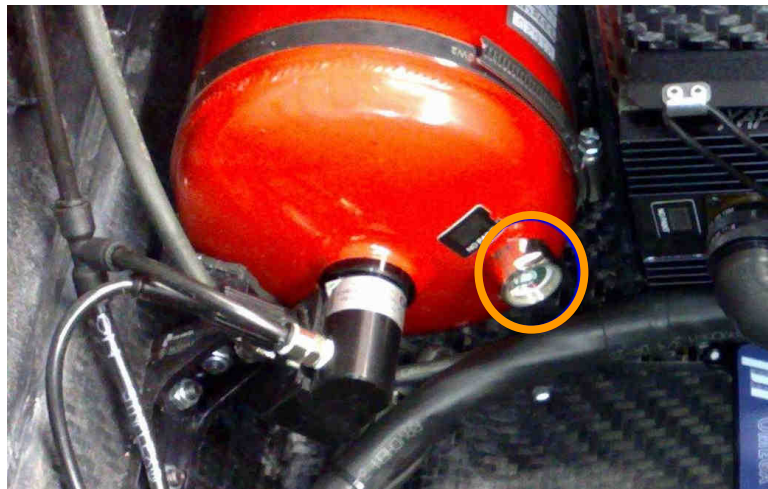
When you'll tighten the rear support on the extinguisher please check that the extinguisher gauge is located as shown on the picture below:

This is necessary to avoid any contact with the extractable seat.

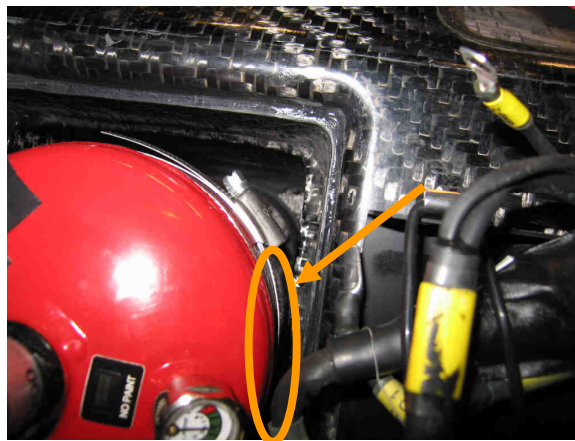
As you are going to remove it, please check if your extinguisher is wearing somewhere else against the tub. In this case, add foam or rubber between the extinguisher and the tub.

For example:
