REFERENCE	BT_2010_FR20_05_UK
DATE	5th March 2010
SUBJECT	Mandatory updates
PART	Switch plate, clutch shaft, chassis loom, fuel tank tower, front damper bracket, Omega, driveshaft outer joint yoke, upper flap support

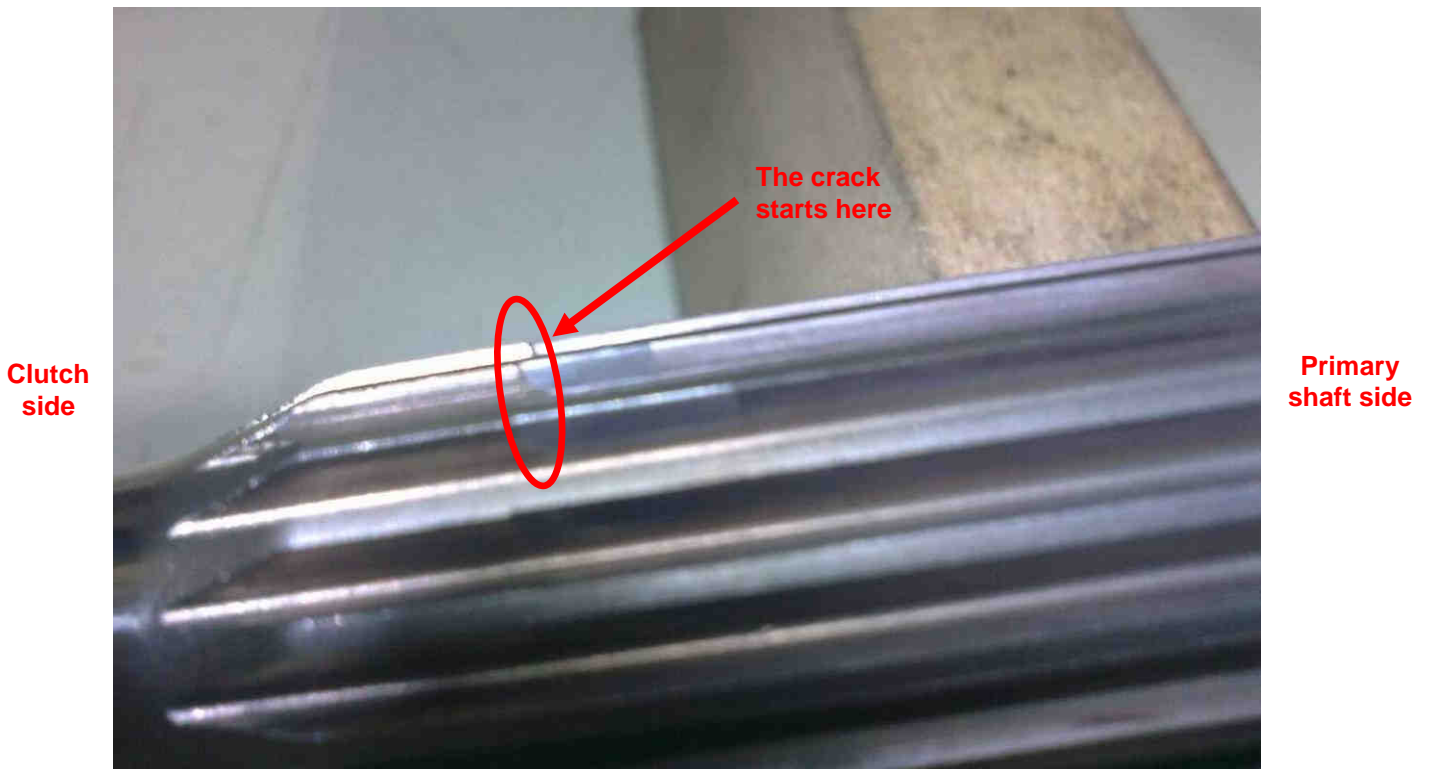
Clutch shaft cracking

As the new parts will not be available before the Motorland tests, we ask all the teams to check their clutch shafts before every session even if they are less than 2,700 km of mileage. For information, please find below a picture of a shaft that started to crack:

A new clutch shaft will be introduced. In order to use it, the primary shaft will have to be modified. Renault Sport will contact you later to explain the update process and schedule.

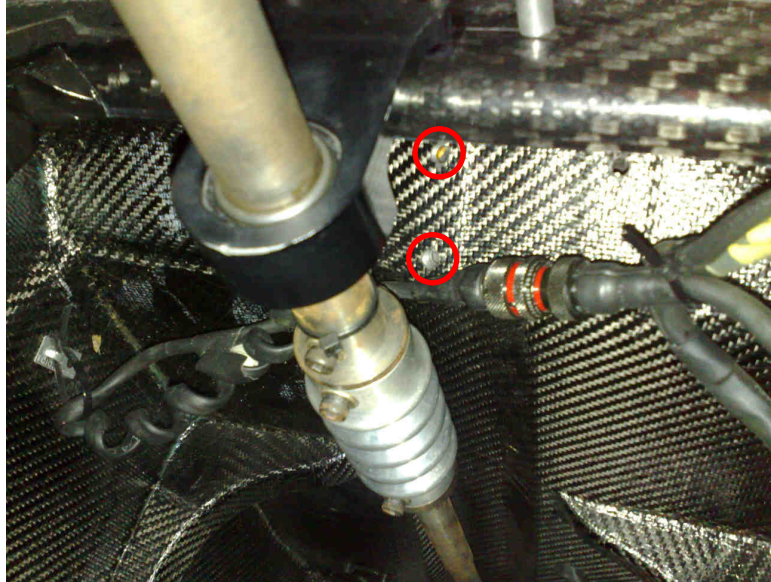
Front damper bracket fitting

On all the cars delivered before the 25th of January, the screws used to tighten the front damper bracket to the chassis are too long. They must be cut as they can damage the upper steering column loom.

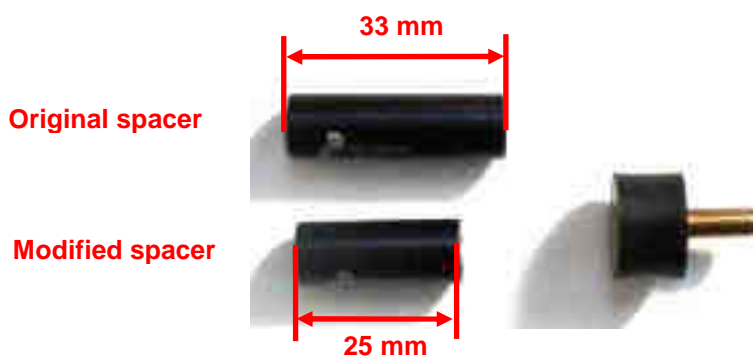
Switch plate mounting

Following several broken wires on the switch plate, we have designed a new wiring specification. New switch plates will be dispatched for free before the first WSR meeting.

In addition to the new switch plates, it is now mandatory to fit the switch plate to the chassis using silent-blocs. These silent-blocs will be available in Barcelona, at the Renault Sport spare parts truck. In order to use these silent-blocs, it is necessary to shorten the spacers and the screws used to fit the switch plate, as shown below:

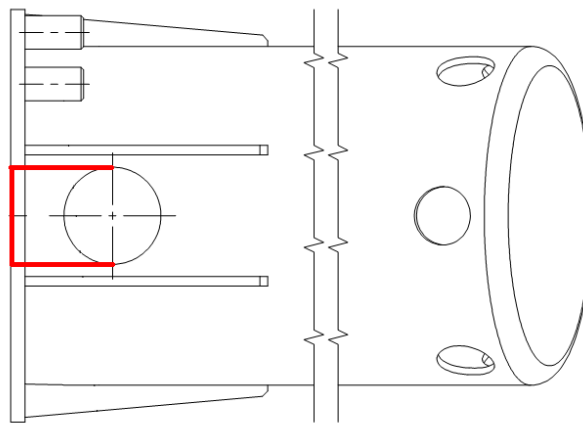
Original part: cut line in red

For safety reasons, It is mandatory to modify the fuel tank tower as shown on the pictures below (after Barcelona tests):

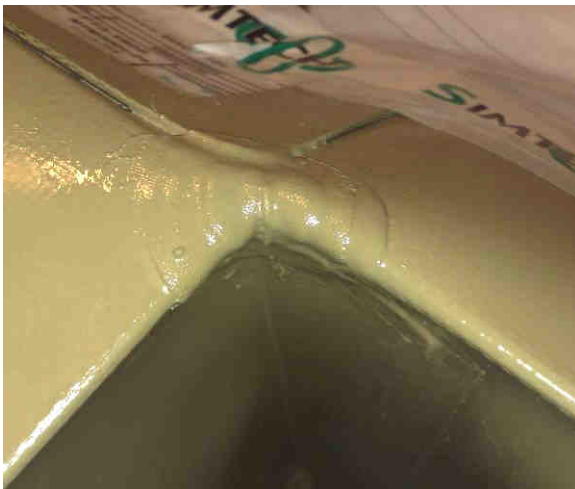
Following fuel tank leaks, the fuel tank specification has been updated. As a consequence, all the fuel tanks must be updated to the last specification. The fuel tanks mounted on all the cars delivered after the 8th of February are already updated.

On sharp edges

Fiber patches have been added on the sharp edges and on all the glued sections:

To update the first fuel tank, they must be sent to Alpine after the Motorland tests. They will be sent back directly to your workshops before the first WSR meeting.

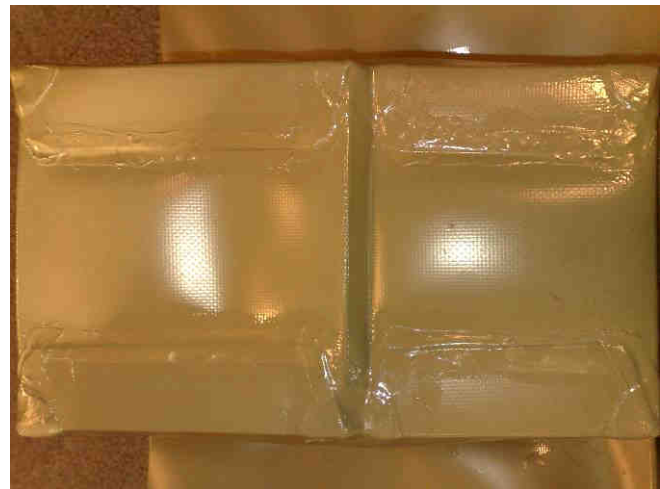
On glued sections

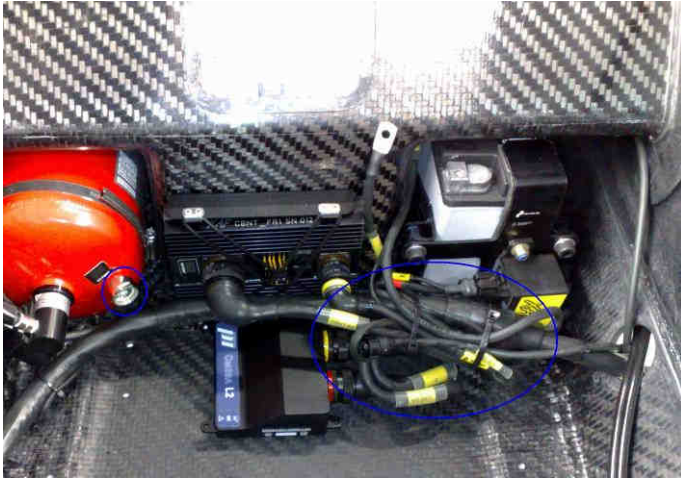
Original and long Omega and CBNT wires

For reliability and mounting reasons, the chassis looms have been modified on all the cars delivered after the 25th of January. The Omega and CBNT wires and also the chassis to engine wire are now shorter. To recognise which type of loom do you have in your car:

All the looms which are not yet modified will be collected at the end of the Magny-Cours tests. They will be dispatched modified on Tuesday the 23rd of March directly in Motorland.

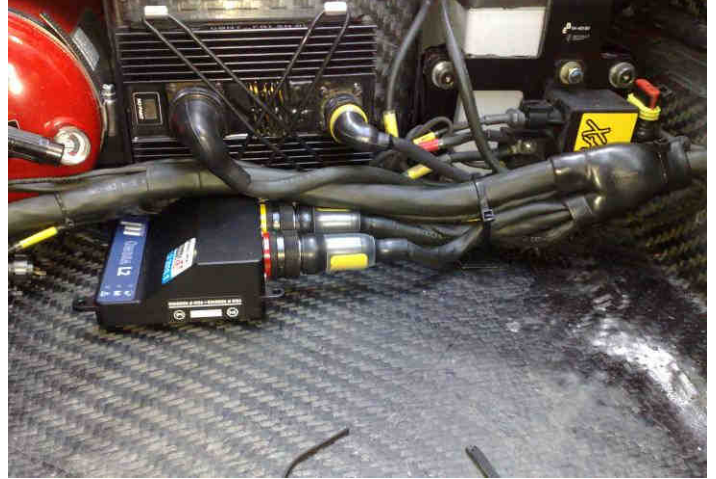
Modified loom

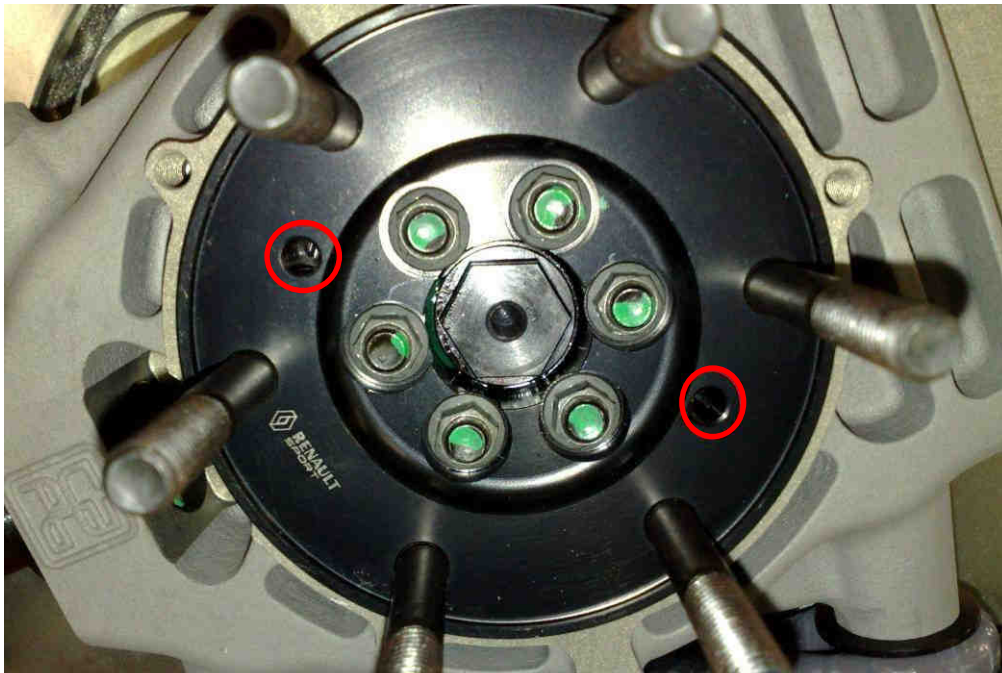
Grease out of the driveshaft joint

In some cases, grease can go out of the joint between the outer joint yoke and the upright. In order to avoid these leaks, it is allowed and recommended to fill the holes designed to remove the yoke from the wheel bearing:

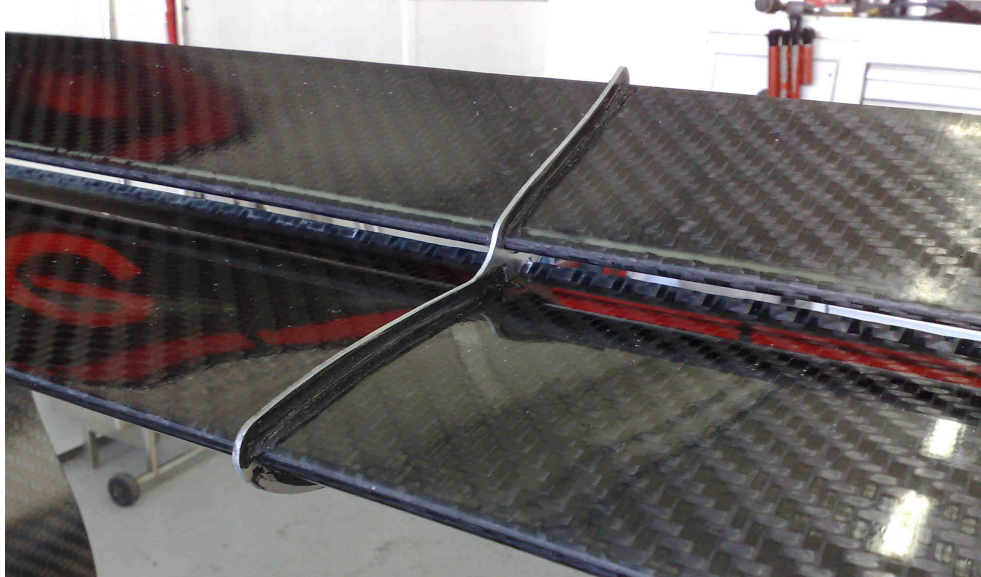
Upper flap support

To prevent the upper flap from bending, a support has been produced. This part will be available at the Renault Sport spare parts truck during Barcelona tests. This support must be fitted with silicon.
