REFERENCE	BT_2010_FR20_07_UK
DATE	2010 March 22 nd
SUBJECT	Provisional modification for Engine oil transfer – Heel-rest – Engine loom modification – Pad retaining bolt
PART	Vortex to catch tank pipe, heelrest, engine looms, brake callipers

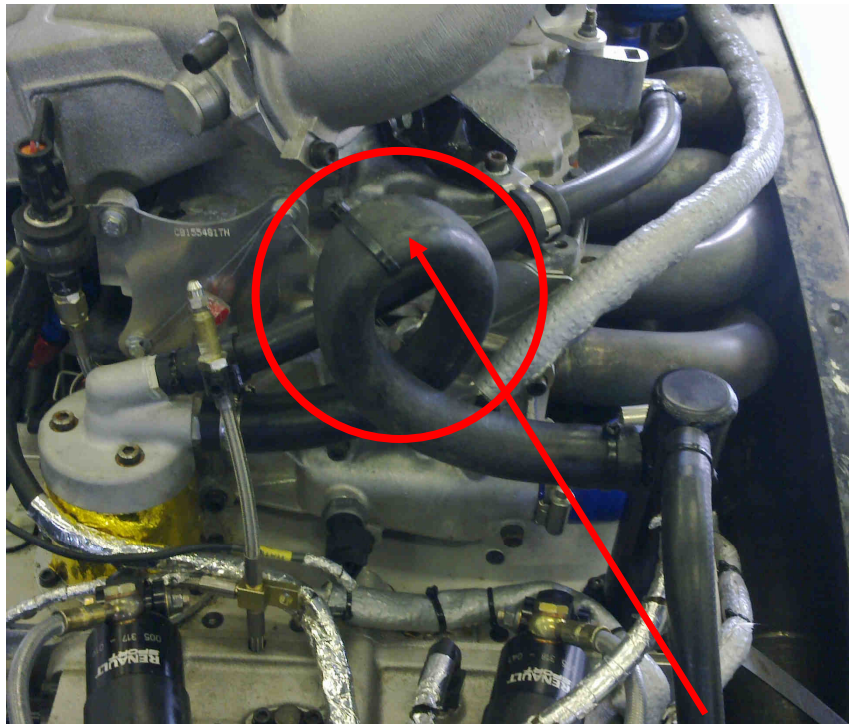
If the pipe is pinched, please add a metallic collar here

This modification significantly slows the engine oil transfer from the oil tank to the catch tank that a majority of cars suffered in Magny Cours. Renault Sport will come back to you with a definitive solution before the first WSR meeting in Motorland.

Renault Sport will be able to provide to the more impacted teams a longer pipe to connect the oil tank to the catch tank as shown below:

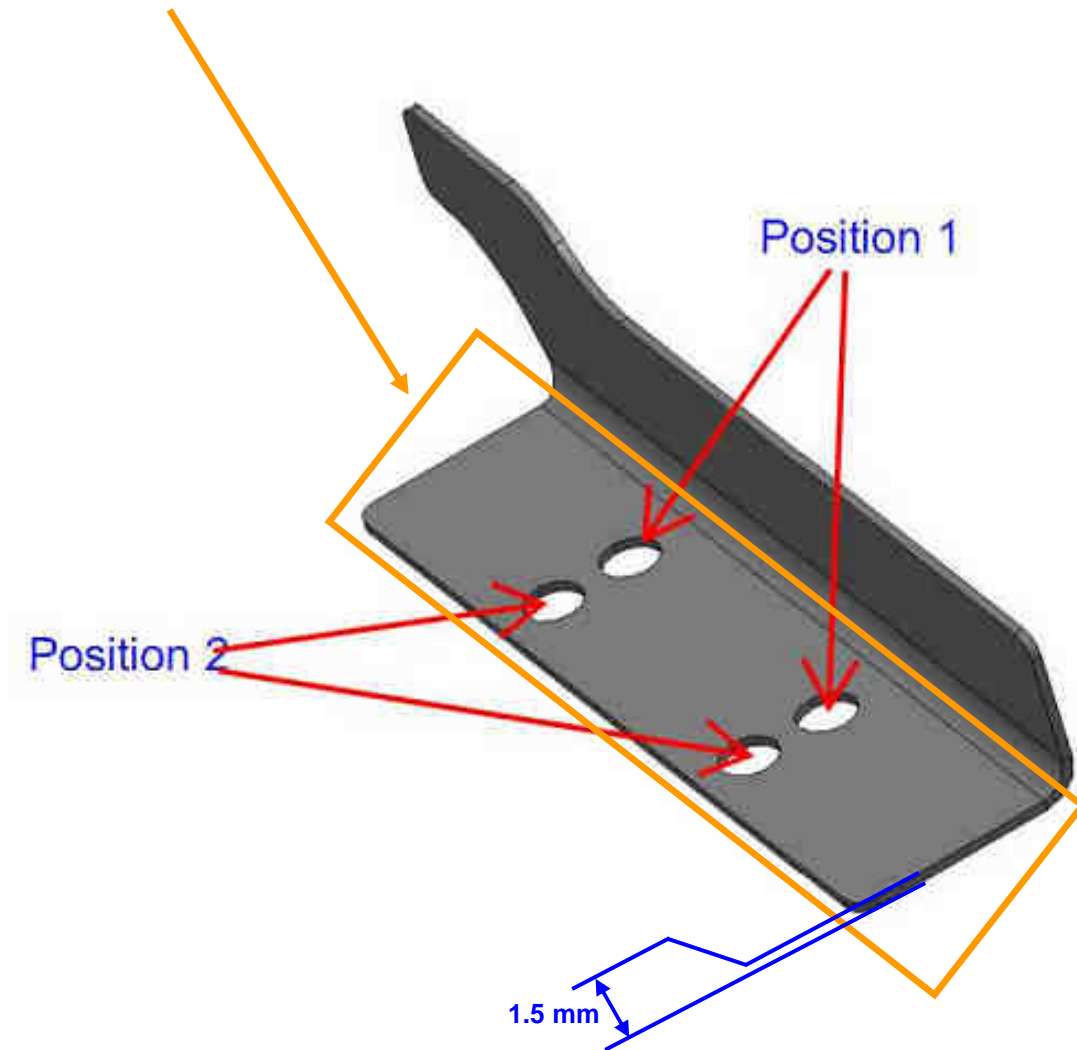
The thickness of the part of the heel-rest which is tightened between the pedalbox and the tub **must be 1.5 mm**:

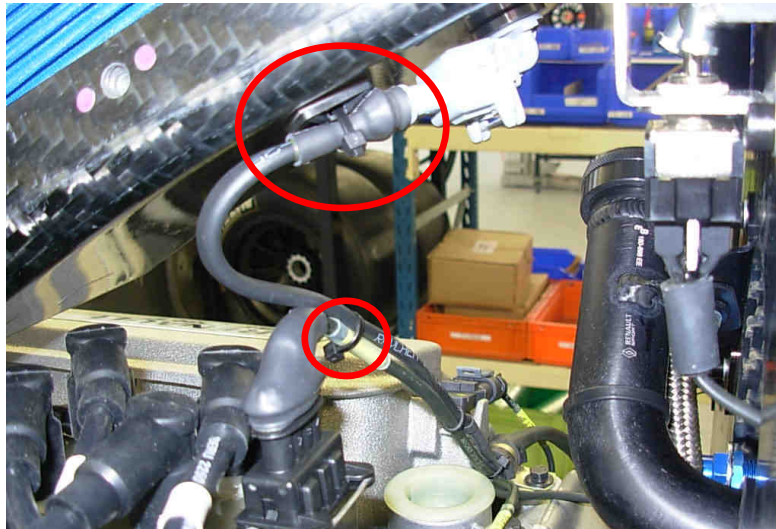
Following reliability issues, Renault Sport will modify all the engine looms on Tuesday 23rd and Wednesday 24th of March in Motorland.

The wires of the air temperature and crankshaft sensors will be updated with a better quality wire as shown on the pictures below:

Please respect this mounting

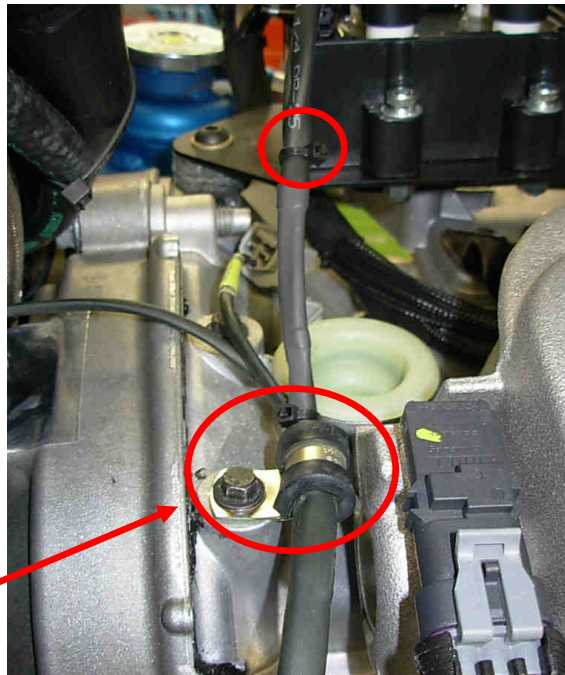
This metallic collar is mandatory and considered as a C category part (available at the Renault Sport spare parts truck in Motorland from Tuesday afternoon). The head cylinder screw must be tightened at 12 N.m.

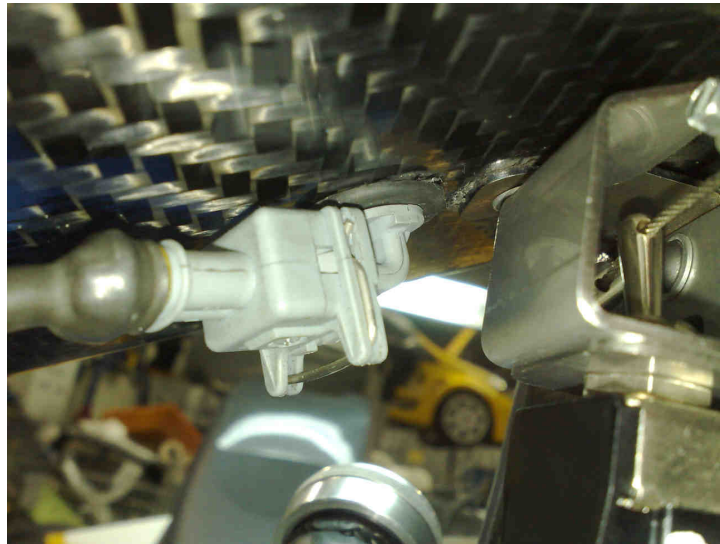
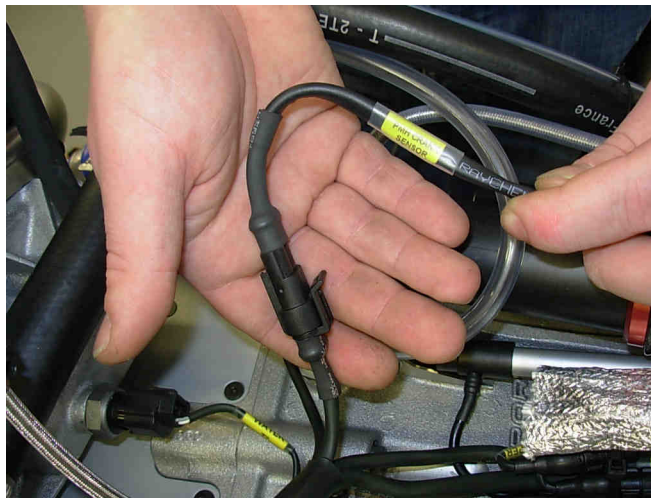
The air temperature sensor is now fitted with a rubber grommet on the airbox. You must remove the aluminium insert and drill the hole at $\varnothing 18\text{mm}$ (Tool available from the Renault Sport technical support). Then put the rubber grommet (available at the Renault Sport spare parts truck from Tuesday afternoon) on the airbox and mount the sensor:

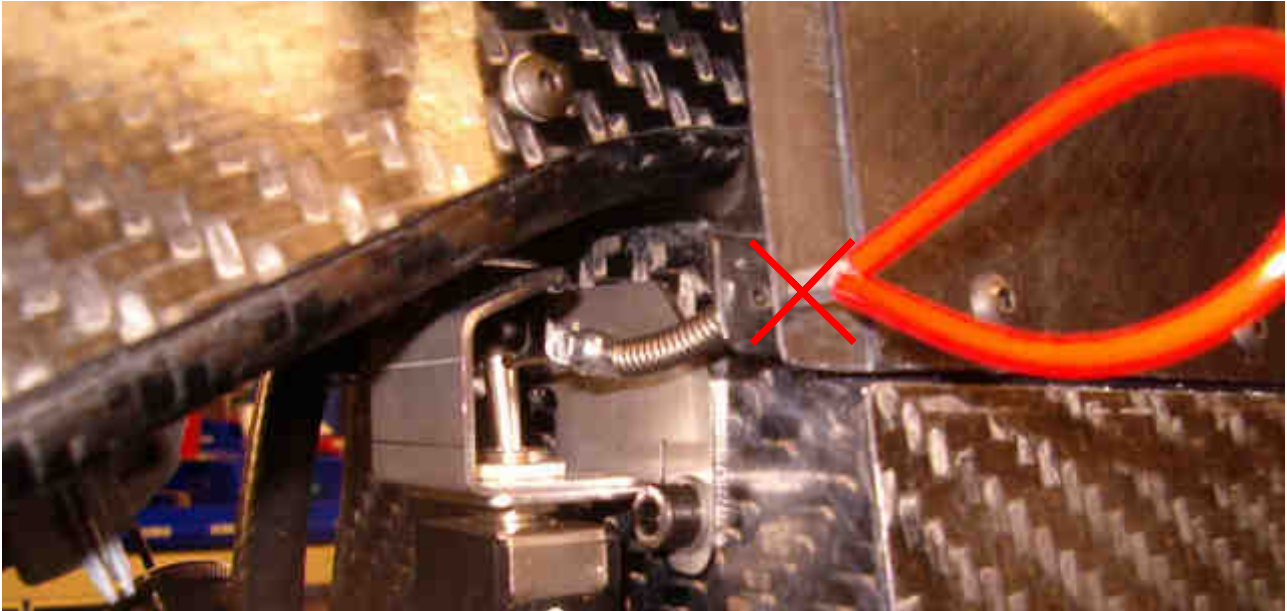
The spring must be enough preloaded between the first cable stop (1) and the roll hoop bracket. There must be a minimal distance of 5 mm between the second cable stop (2) and the switch lever.

The hole in the roll hoop cover must be enlarged to permit the cable loop to stop against the roll-hoop bracket (3) and not against the roll hoop fairing (4) like on the above picture.

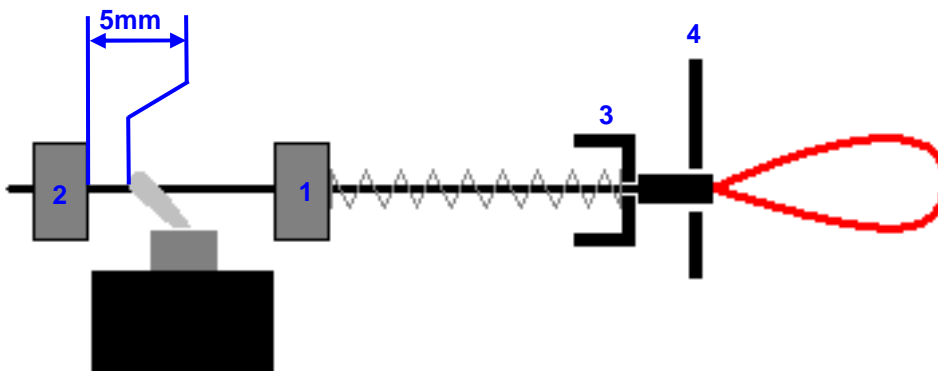
It is allowed to trim a little bit the engine cover around the master switch cable. This modification is recommended as the engine cover may pull the cable in some specific cases.

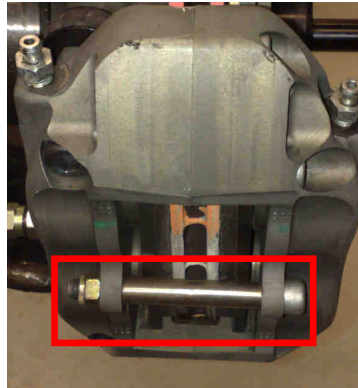
Following several mounting and unmounting operations, the spacer which is on the pad retaining bolt can deform. As a consequence when you tighten the bolt you also deform the calliper and it could get broken. For this reason, one must only put the nut in contact with the calliper (5N.m max.) rather than tighten the bolt at 13.5N.m as it is written in the User Manual (values will be updated in the new release).
