REFERENCE	BT_2010_FR20_22_UK
DATE	5 th October 2010
SUBJECT	New ECU software release 2010.3, gearbox casing
PART	ECU, gearbox casing

2. Gearbox casings crack

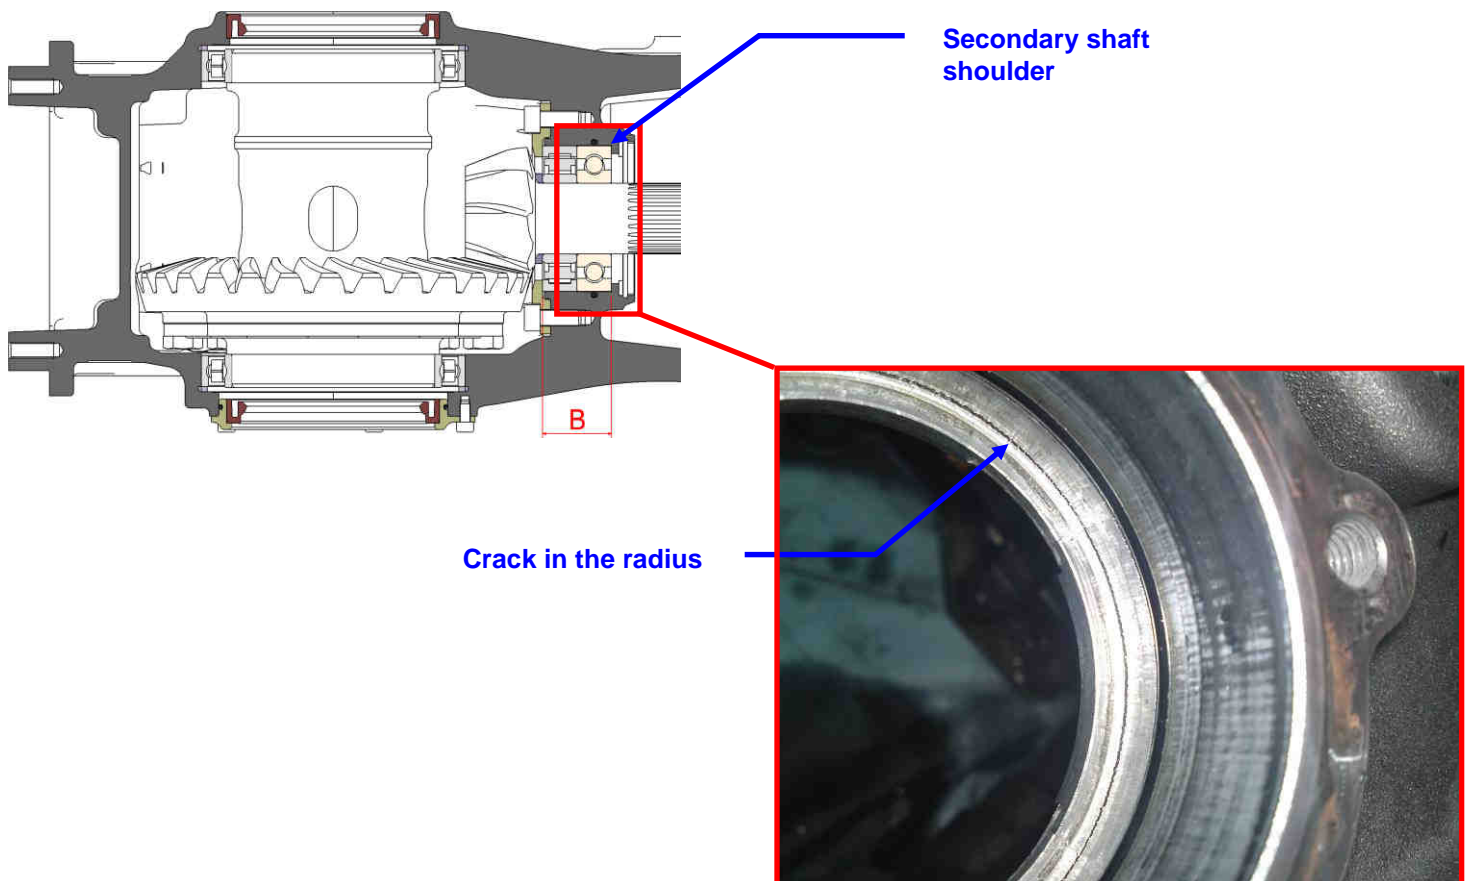
A few gearboxes have been broken due to a gearbox main casing problem.

The aluminium shoulder, which axially retains the secondary shaft, can crack and then break. This may result in the reverse gear engaging at the same time with the first gear, causing big damages to the gearbox.

The crack is located behind the bearings of the pinion of the bevel gear.

For this reason, Renault Sport asks you to check your gearbox casing as soon as possible. Please contact a Renault Sport representative should you notice any problem in your gearbox.

A new and improved casing should be soon available at a promotional price.
