REFERENCE	BT_2011_FR20_10_UK
DATE	12th May, 2011
SUBJECT	actuator spring modification
PART	GB actuator

### 1. Actuator spring modification

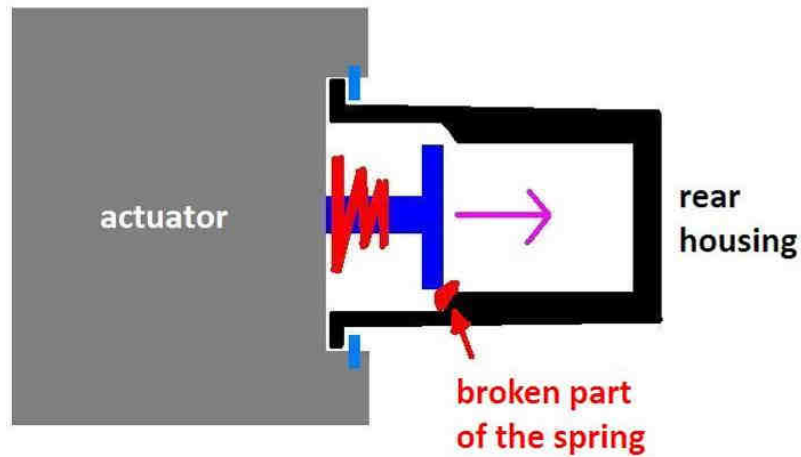
The spring which is at the back of the actuator may break under specific conditions, causing gearshift issues. For this reason, Renault Sport recommends to remove the rear housing of the actuator to check if the spring is already broken or not.

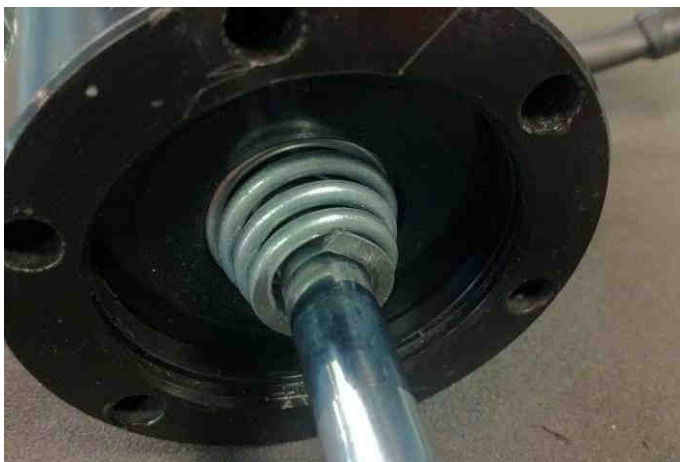
Before

The red part must be removed (aprox. 5mm)

If the spring is not broken yet, it is mandatory to modify it as described below:
