REFERENCE	NI_2014_FR20_07_UK
DATE	July 4th, 2014
SUBJECT	Crashbox repair procedure reminder, accelerated engine wear mode, new Toolbox 6.3 software release

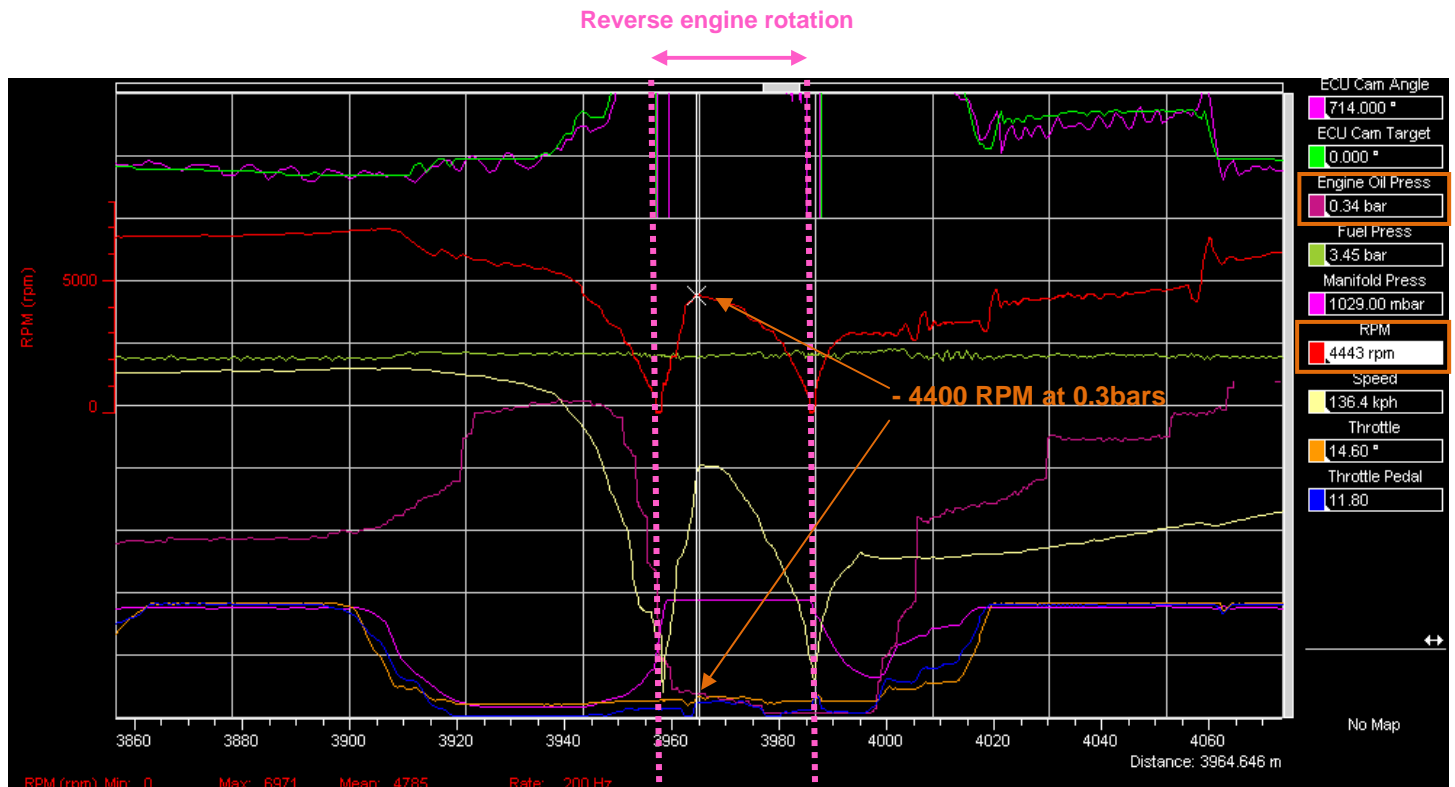
Following a few engine failure occurrences, deep analysis have pointed out a correlation between violent reverse rotation drive of the engine (happening during car spins when clutch not engaged or activated too late by the driver), and accelerated engine wear. Indeed, in reverse rotation, the oil pump does not fill the engine with pressurized oil but suck up the oil from the engine increasing parts friction.

In order to figure out the degree of potential engine damage brought during a car spin, please see below a typical example: the engine ran at 4400revs in reverse rotation according almost no oil pressure.

Such reverse engine rotation has a potential negative effect on reliability and it has been recommended to send the engine for check to ORECA.

As we cannot quantify the extent of damages during engine reverse rotation (depending on number of occurrence, speed, maximum invert RPM, oil pressure, etc...), we do recommend teams, in case of doubt, to send their engines for check to ORECA who will be able to detect any negative impact on engine parts wear. We also recommend teams to highly brief their drivers to press the clutch as soon as the car starts to spin.
