REFERENCE	BT_2010_FR20_05_UK
DATE	5th March 2010
SUBJECT	Mandatory updates
PART	Switch plate, clutch shaft, chassis loom, fuel tank tower, front damper bracket, Omega, driveshaft outer joint yoke, upper flap support

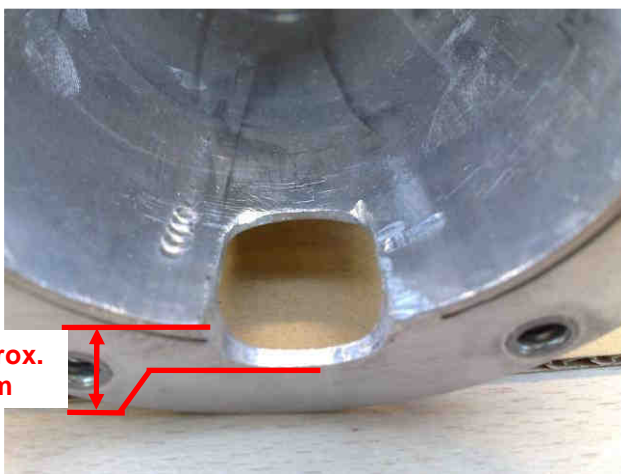
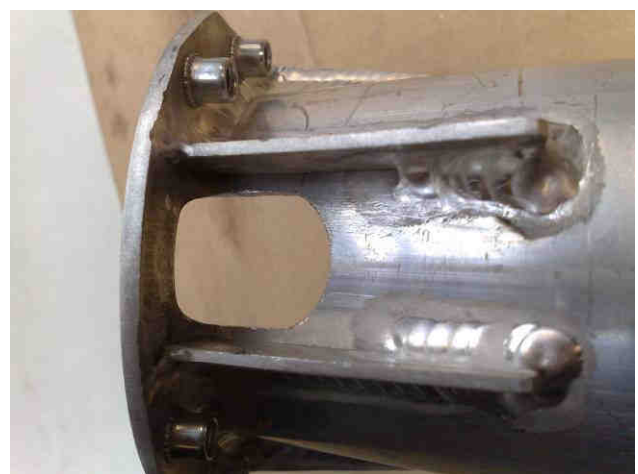
Moreover, it is mandatory to add seals on the screws used to tighten the tower onto the fuel tank cover. On the car delivered after the 20th of January, 4 seals are already mounted:

These modifications are already made on all the new cars delivered after the 20th of January.
