FORMULA RENAULT 2.0 2009 BODYWORK

BODYWORKContents

BODYWORK

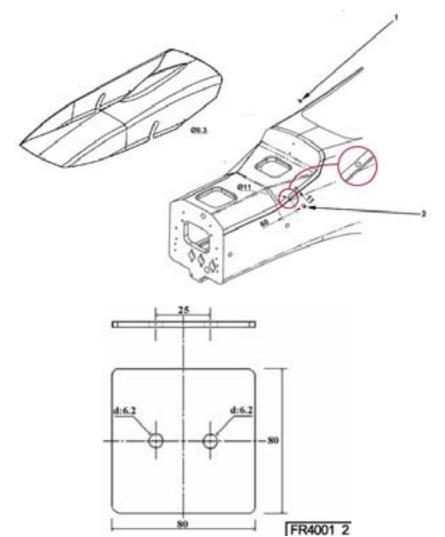
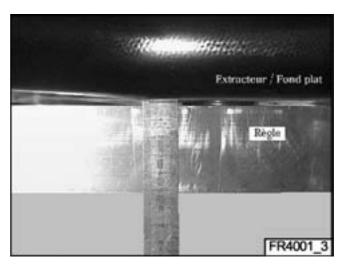
To respect the article 3.13 of the technical regulation, it is authorised to add between the aerodynamic extractor and the support of the pad a metallic spacer plate following the sheet here on the right.

The thickness permitted the location of the aerodynamic extractor to be in line with the reference flat bottom.

CHECKING PROCEDURE

Position a ruler under the flat bottom (reference plane) in the longitudinal plane of the vehicle by placing it near the pad and measure the distance between the ruler and the flat bottom. If the distance is more than 5mm (0.197in), it is compulsory to set up a shim between the pad and the gearbox to respect the regulation.

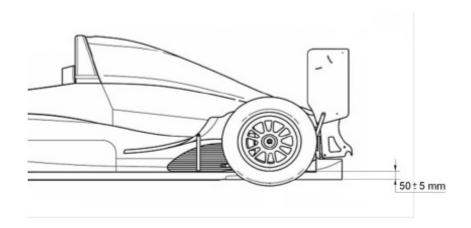
<u>IMPORTANT:</u> Rear diffuser: a tolerance of ± 5mm is granted on the relative position of the extension of the step plane on the further rear edge of the diffuser with regard to the reference plane (see drawing below). This adjustment can be obtained by adding washers or shims between the stay main plate / diffuser (part 01 03 02 060/061) and the diffuser.

Between the furthest-rear edge of the complete front wheels and the furthest-forward edge of the complete rear wheels, all suspended parts of the car visible from below must be located on one of the following two parallel planes: the reference plane or the step plane.

Reference plane: surface between the furthest-rear edge of the complete front wheels and the furthest-forward edge of the complete rear wheels with a maximum width of 500mm symmetrical to the longitudinal axis of the car.

Step plane: all suspended parts of the car visible from below and not in the reference plane, must be positioned 50mm above the reference plane.

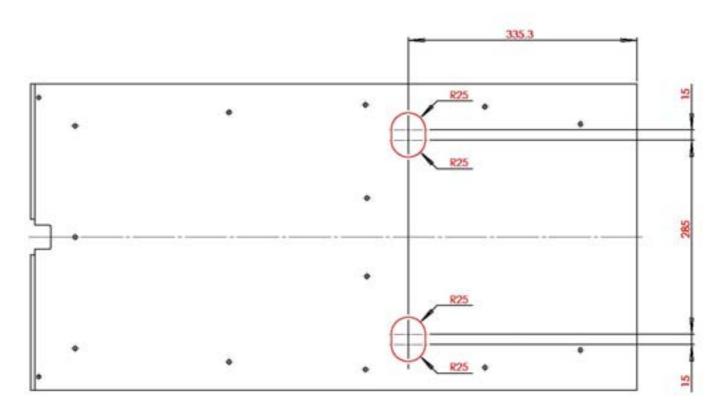
The central wooden floor (ref 77 11 163 104) must be drilled in order to enable the Renault Sport scrutineers to check all the cars on the Renault Sport control plane. Two holes must be drilled according to the drawing below:

NOTA: This modification is compulsory for all the Formula Renault 2.0 championships.

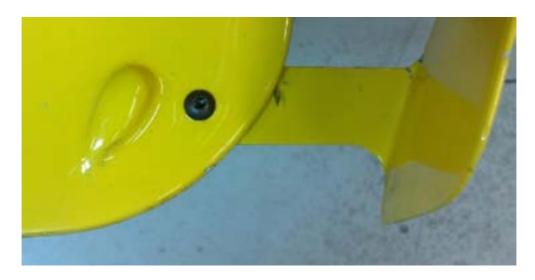
2. Drill the flat bottom and the rear support (Ø5mm) and fit a M5 bolt with a locknut:

NOTA: this screw must be a M5 screw as the original one.

It is compulsory to improve the rear barge board support adding a new screw (flat bottom side) following the pictures below :

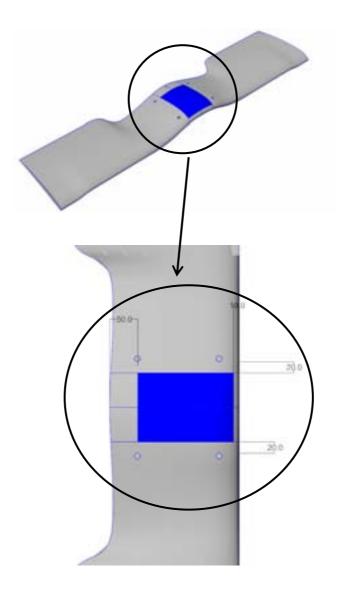
Fig. 1

The front wing must be replaced if the erosion is outside the blue area (fig.1) and if the erosion depth is greater than 1.0mm.

Otherwise, the wing can be repaired with wet lay up, use epoxy resin and carbon fibre.

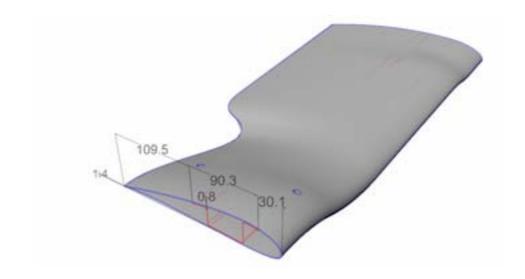
Fig. 2

- 1. Clean the erosion area.
- 2. Apply the necessary number of carbon fibre ply to restore the skin thickness at 1.4 mm (fig. 2, 3).
- 3. Normally the resin cures at room temperature with the use of an accelerator and a catalyst. Post curing of cold (max 80°C) cured laminates is recomm ended.

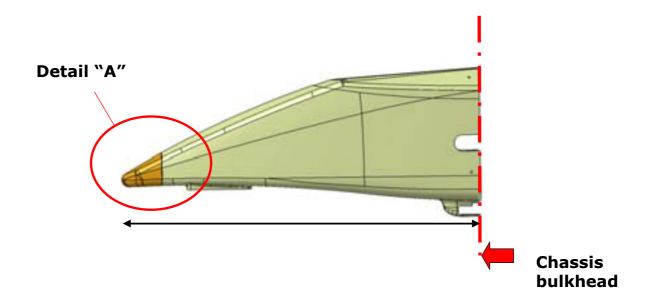
The following procedure is applicable only when the damage is contained in the first 80mm from the nose tip (820mm from the chassis bulkhead), all the other damages must be inspected by the manufacturer.

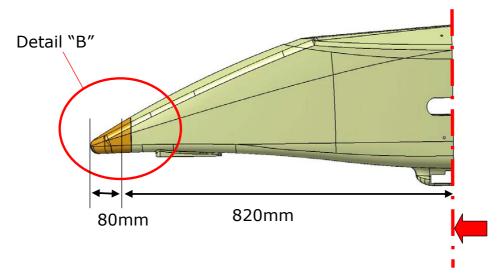
2. Trace a line parallel to the chassis bulkhead 80mm from the crashbox tip, you should find the line 20mm from the old nose tip junction.

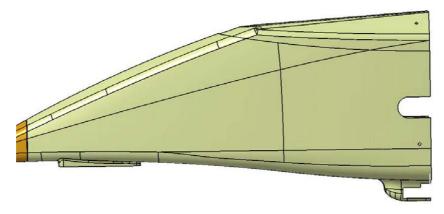
3. Cut off the nose tip forward the traced line:

4. Using sandpaper reduce the thickness of the crashbox by about 1mm for a depth of 20mm (red area).

Attention must be paid to sandpaper at this stage the outer surface, at the depth of 1mm you should be able to find the resin surface (the old carbon ply should be gone).

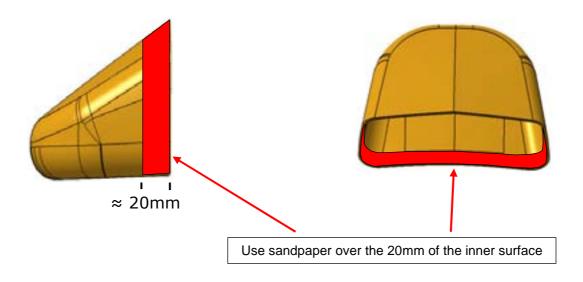
6. Spread specific resin 3M 9323 over the junction surface, carefully respect the percentage between resin and catalyst:

Uniformly spread resin 3M 9323 on the highlighted surface

3M 9323 Mixing specification:

Resin	Catalyst
Weight ratio	100g	27g
Volume ratio	100g	31g

5. Use sandpaper on the new nose tip inner surface to produce a rough surface that will match the outer surface of the crashbox.

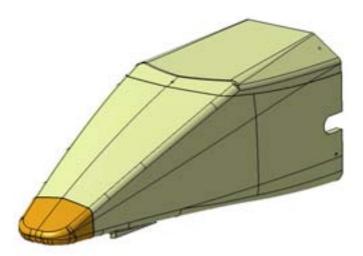
7. Put in position the new nose tip cleaning the excess of resin; new nose tip can be hold in position with high temperature tape.

8. Cure the assembly on the oven following the specific temperature cycle for 3M 9323:

2 hours at 60℃

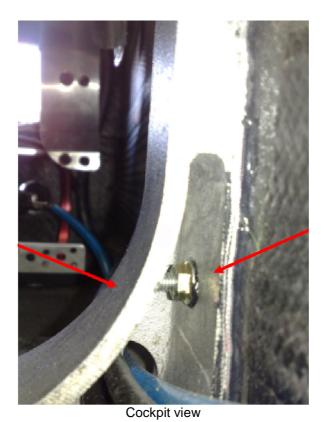
In order to make easier any upper front barge board support repair, it is allowed to fit it with a M5 stud (8.8 minimum class quality required) right through the tub, fitted as shown on the picture below:

External side

Internal side

NOTA: it is mandatory to respect a maximum diameter of 5 mm to drill the tub. It is only permitted to drill the external side of the aluminium frame.

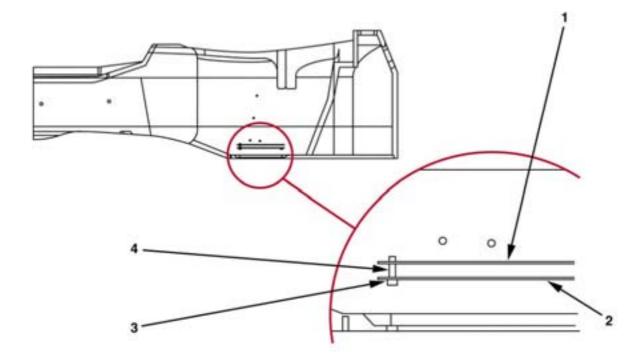
- Fit bottom plate (2). Align it with edges of body shell sunk spot.
- Use bottom plate (2) as gauge to drill body shell.
- Drill four holes for inserts (3) and 3.2mm dia. holes for rivets.
- Run sandpaper over body shell and bottom plate sections to be glued.
- Glue bottom plate (2) onto body shell using Scotch 3M Wild 9323 a/b resin, then fasten it with rivets.
- Screw the four studs (4) onto the inserts (3).
- Adjust their length as a function of the ballast thickness.
- Assemble top plate (1).
- Drill end of studs so sealing can be applied.

In order to respect the regulation with regard to the minimum weight of the vehicle, ballast plates specific to the FR 2.0 are available in the Renault Sport equipment store - Ref : 77 11 154 298.

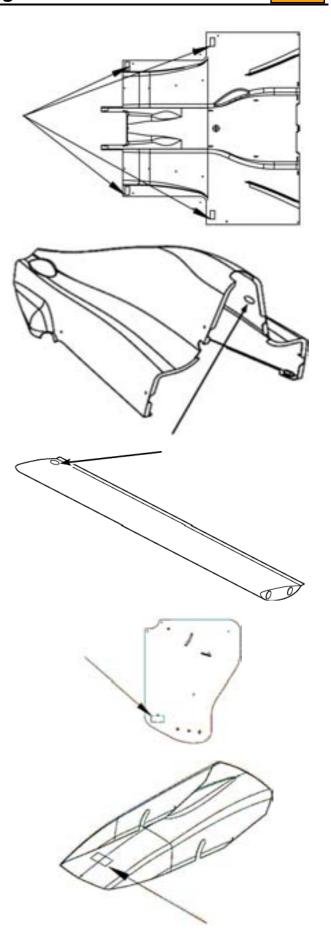
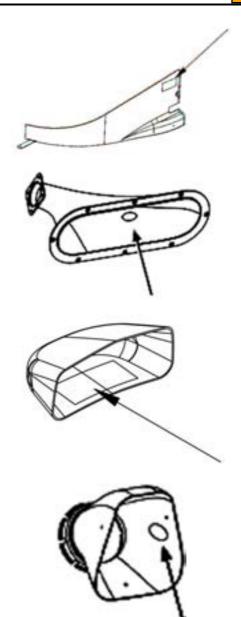
All parts making up the bodywork, wings and bow are marked with hologram discs.

Contestants are in charge of the condition of discs. The arrows in the figures opposite show the location of the discs.
